## REPAIR OF WATERLINE ON TAILGATE

# AVANTIME

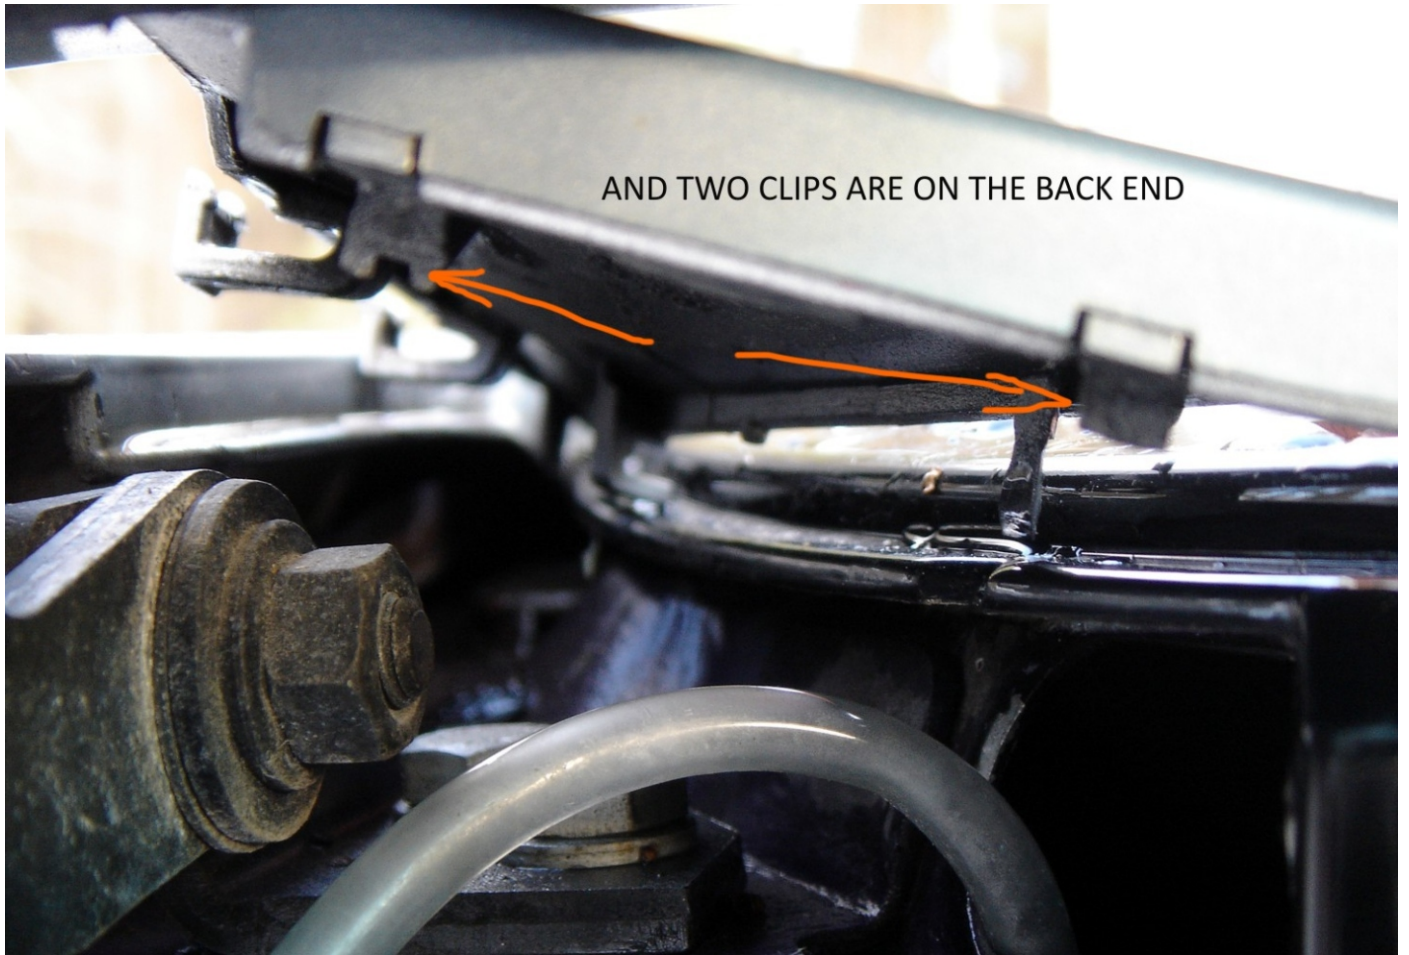
AND TWO CLIPS ARE ON THE BACK END

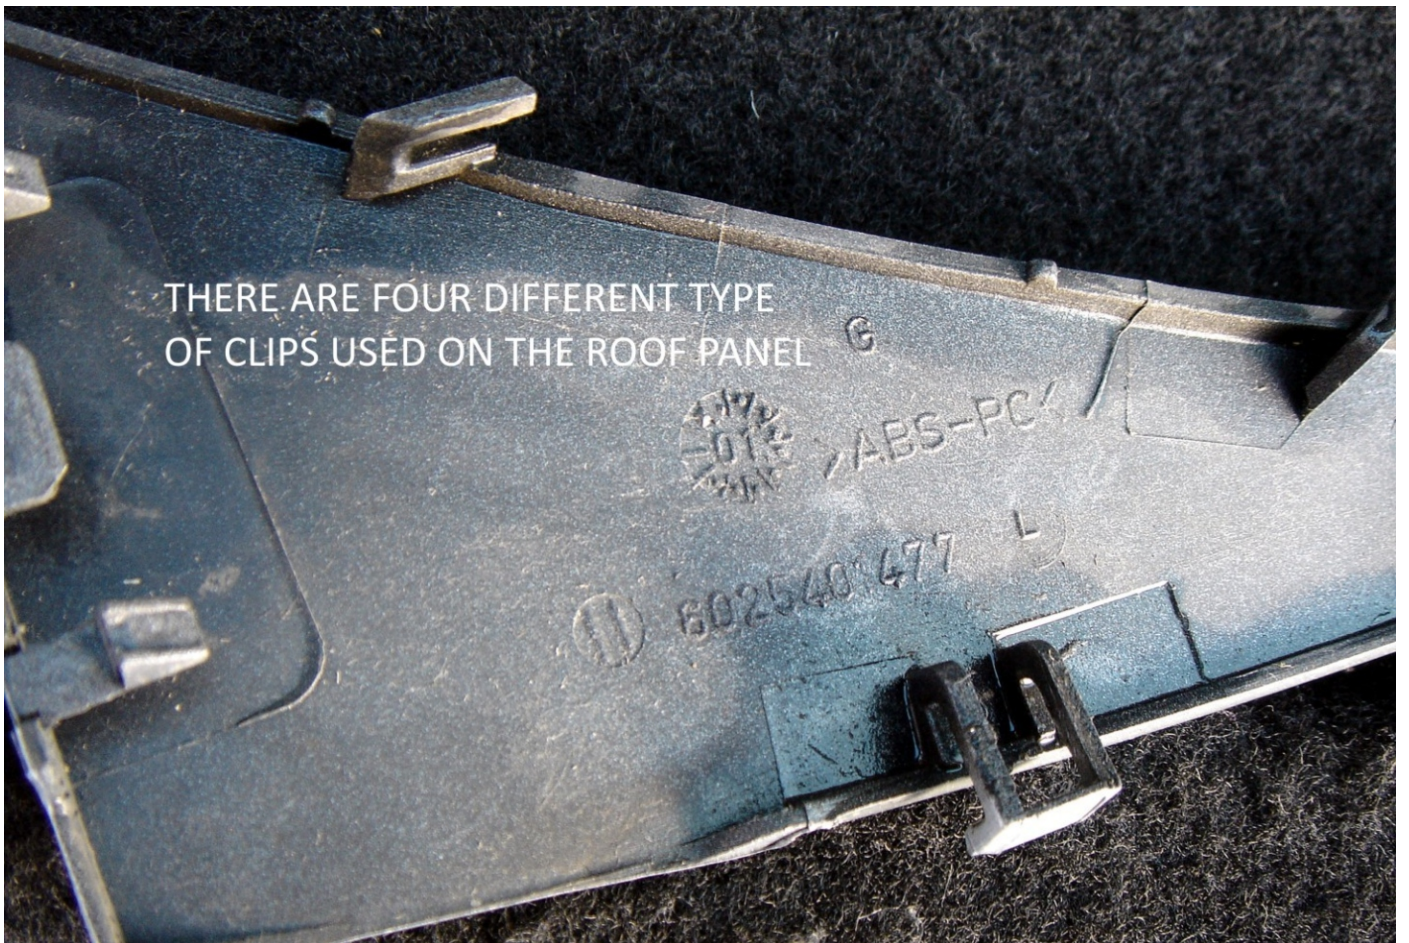
THERE ARE FOUR DIFFERENT TYPE  
OF CLIPS USED ON THE ROOF PANEL

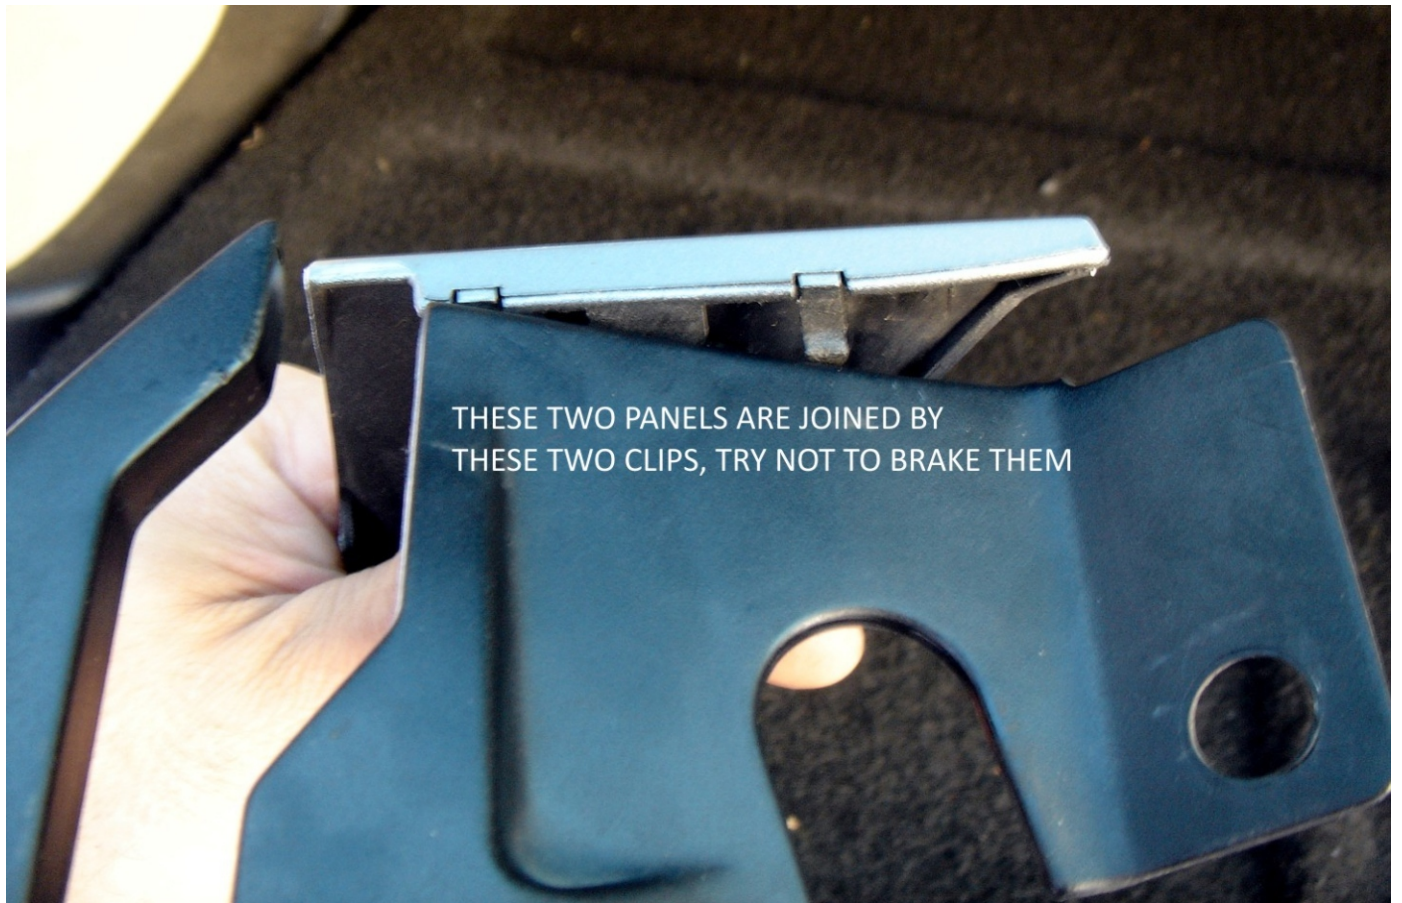
THESE TWO PANELS ARE JOINED BY  
THESE TWO CLIPS, TRY NOT TO BRAKE THEM

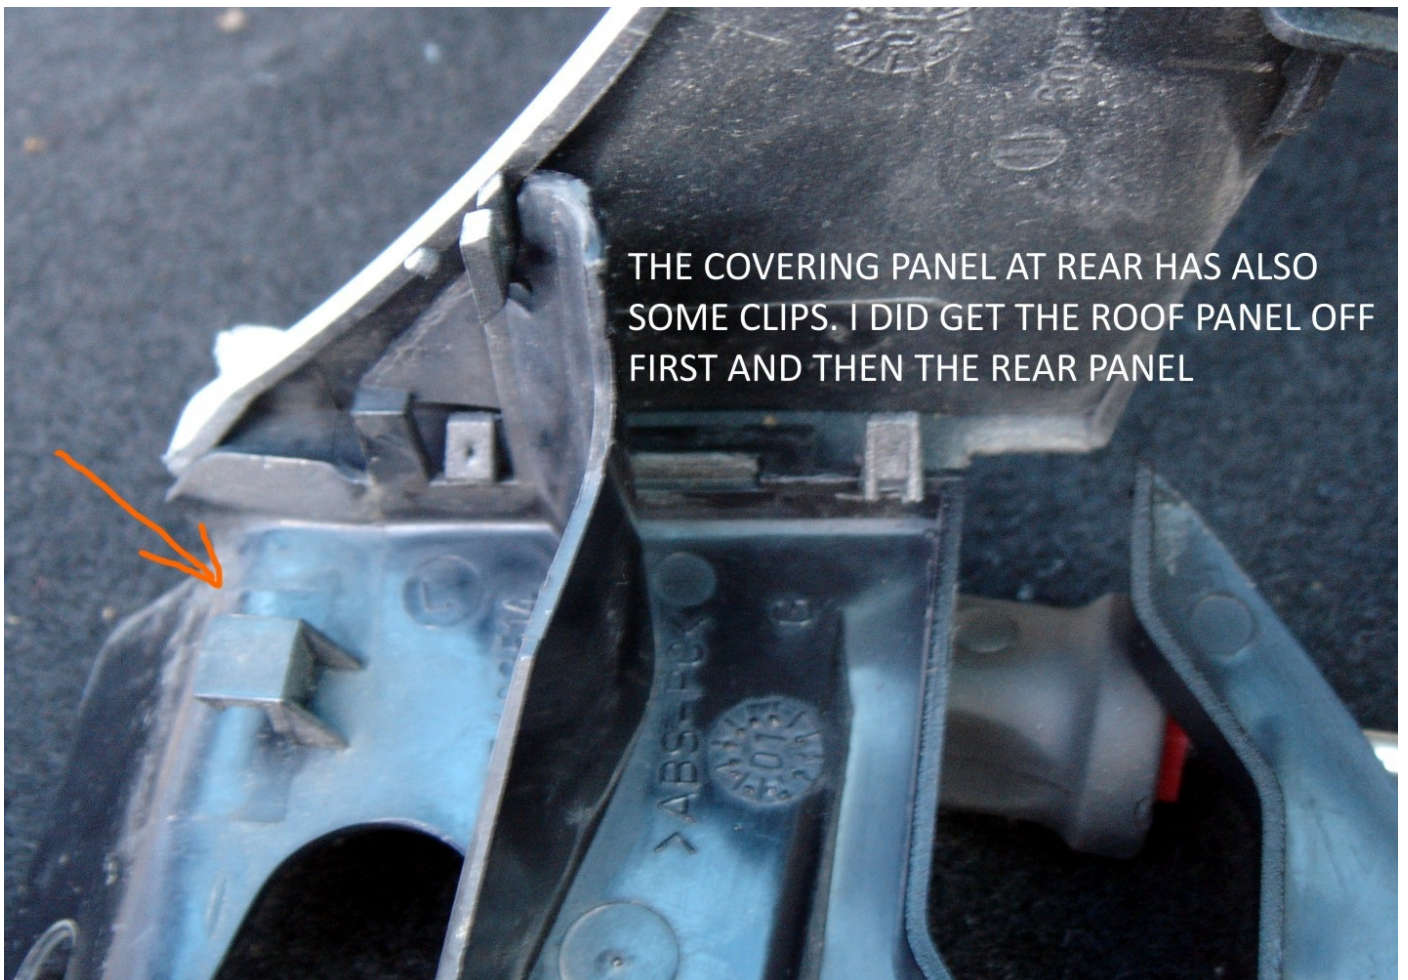
THE COVERING PANEL AT REAR HAS ALSO  
SOME CLIPS. I DID GET THE ROOF PANEL OFF  
FIRST AND THEN THE REAR PANEL

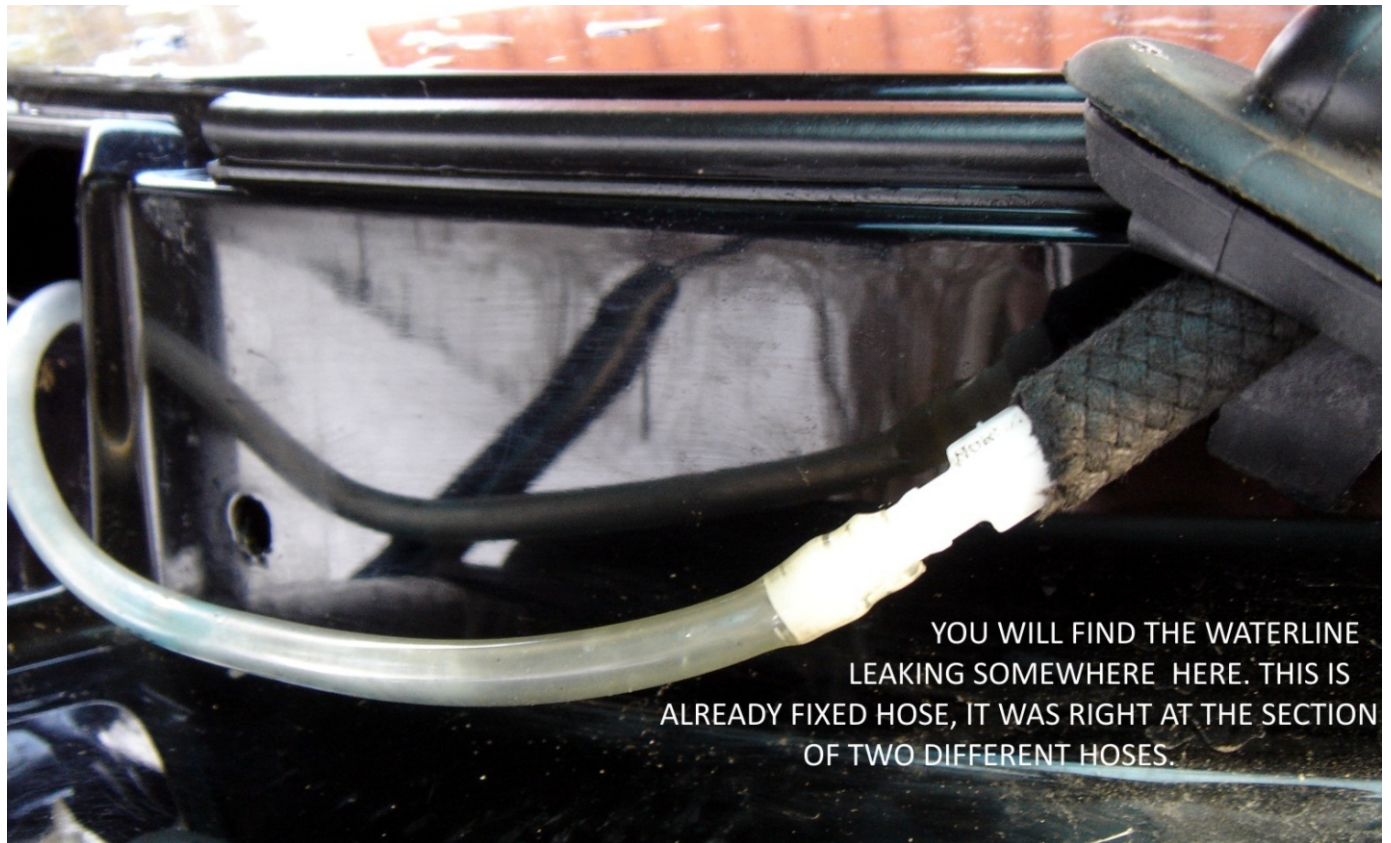
YOU WILL FIND THE WATERLINE  
LEAKING SOMEWHERE HERE. THIS IS  
ALREADY FIXED HOSE, IT WAS RIGHT AT THE SECTION  
OF TWO DIFFERENT HOSES.

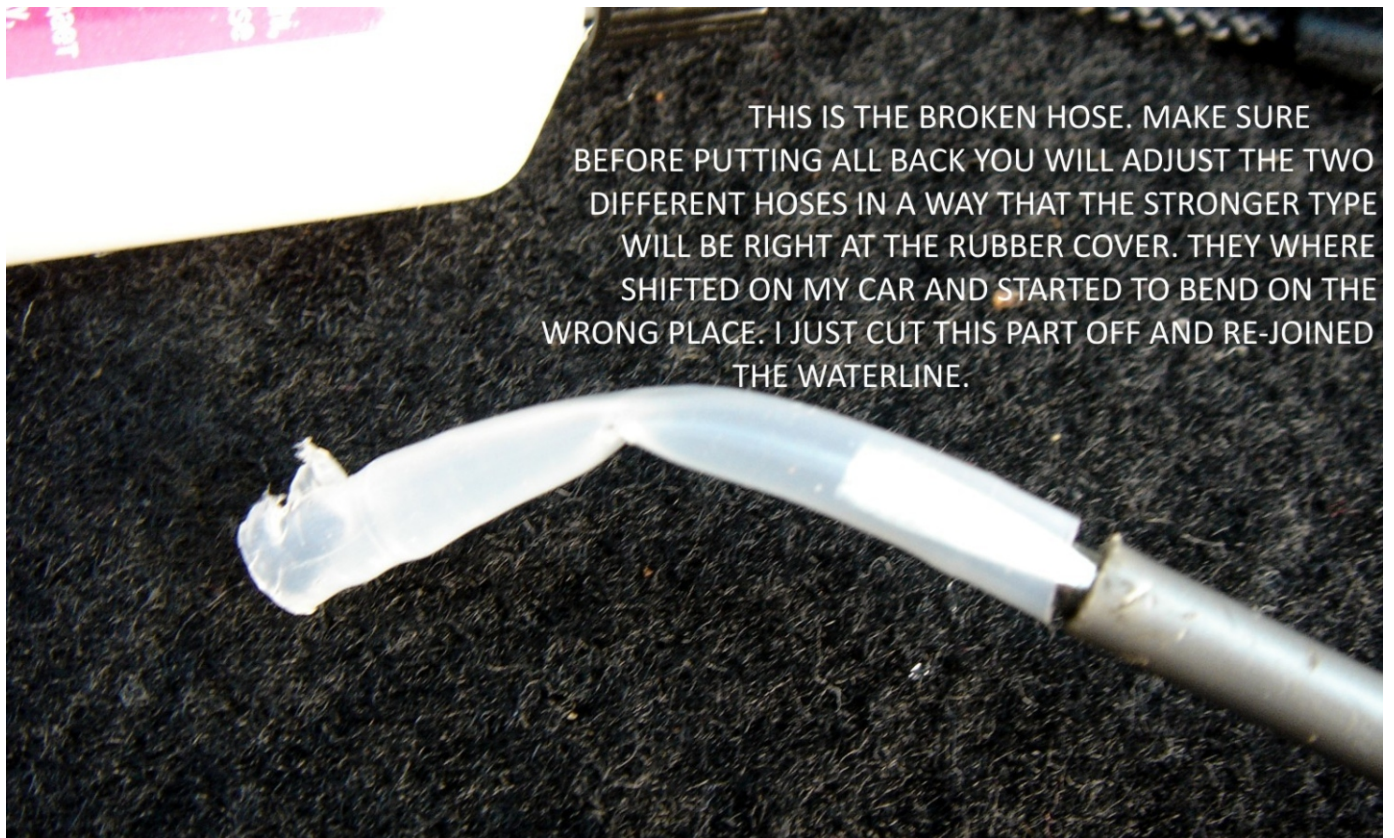
THIS IS THE BROKEN HOSE. MAKE SURE  
BEFORE PUTTING ALL BACK YOU WILL ADJUST THE TWO  
DIFFERENT HOSES IN A WAY THAT THE STRONGER TYPE  
WILL BE RIGHT AT THE RUBBER COVER. THEY WERE  
SHIFTED ON MY CAR AND STARTED TO BEND ON THE  
WRONG PLACE. I JUST CUT THIS PART OFF AND RE-JOINED  
THE WATERLINE.

USE SOME GREASE OR OIL TO HELP IT GETTING BACK
